Report ID: 343056

Sample name: ATLANTIC TABLE

SAMPLE N° 343056

List of test reports:

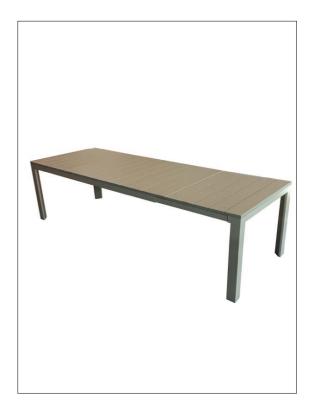
Overall dimensions: 2800 x 1000 x 760 (h) mm
